MoniServ, Inc.

Remove and install Backlight Inverter procedure for ViewSonic VP181

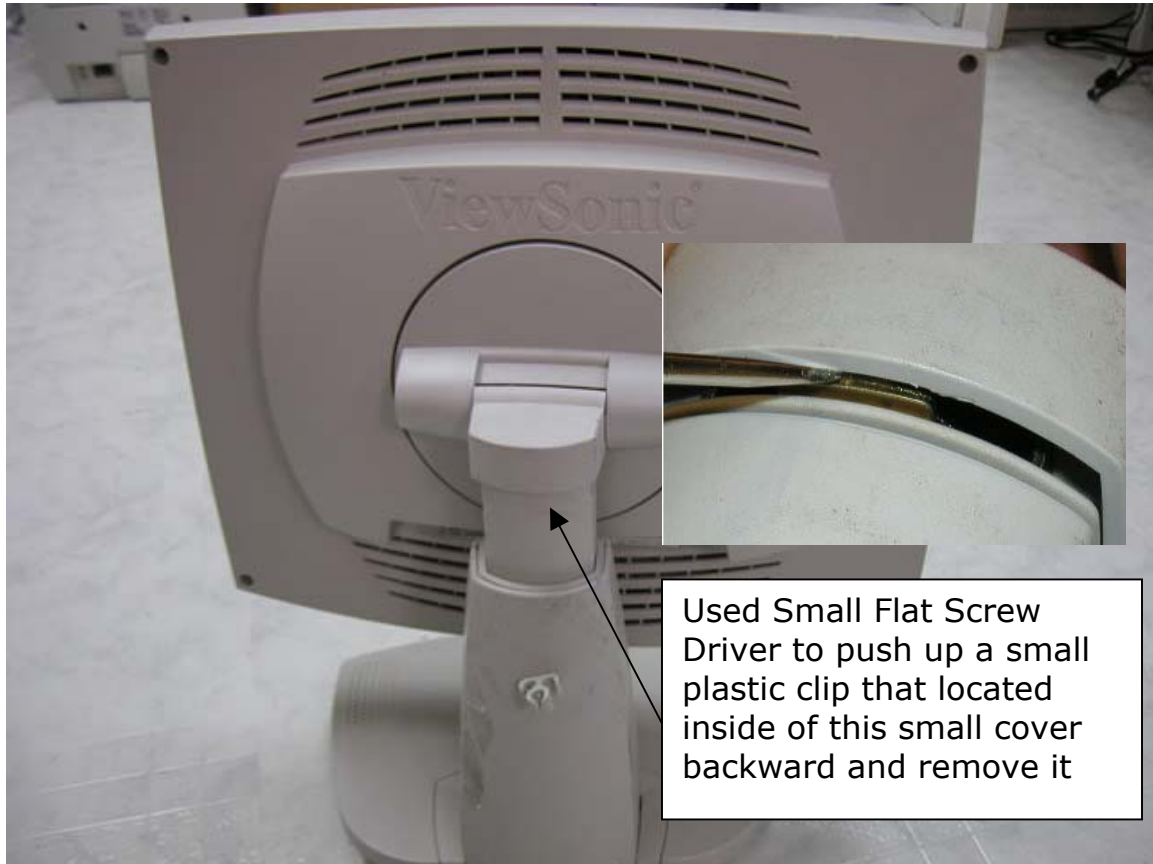
Note: The easiest to remove this small cover would be set the monitor face down.

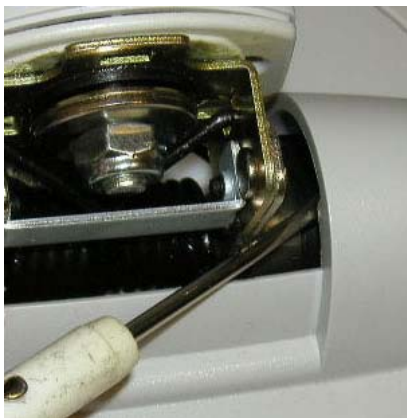
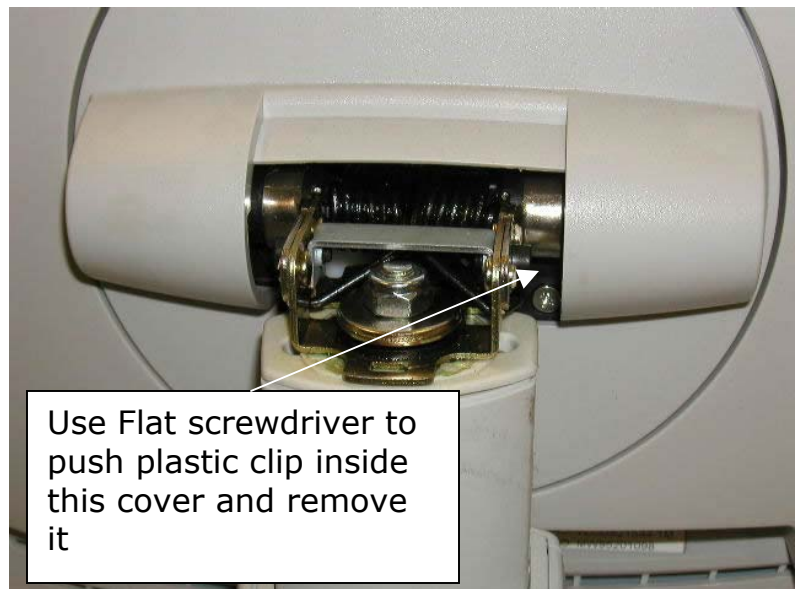
Note: There are two small plastic clips on both side of this cover, you just need to push one side and it can be easily remove.

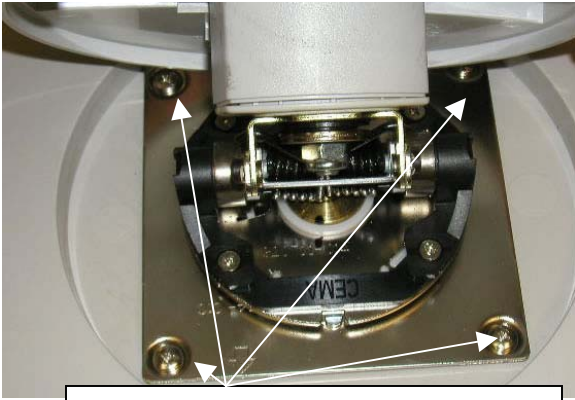
Unscrew 4 screws and
remove swivel base

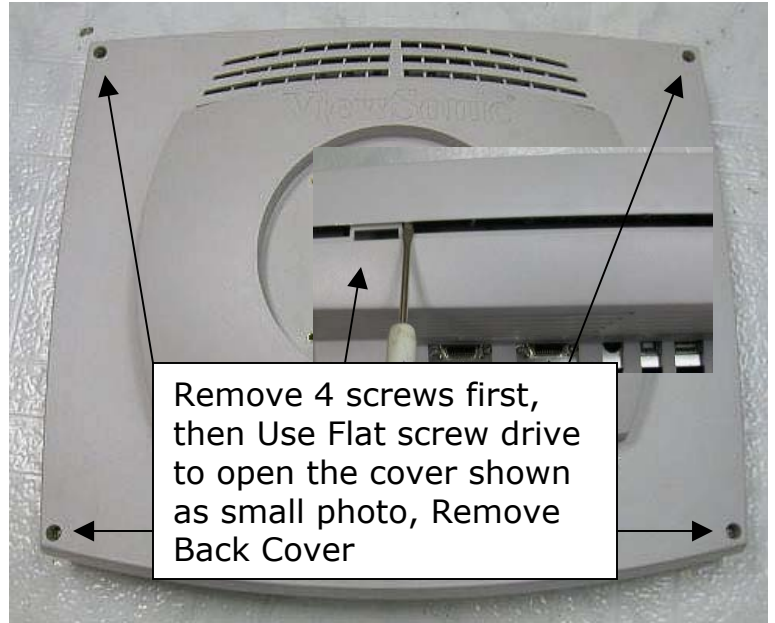
Remove 4 screws first,
then Use Flat screw drive
to open the cover shown
as small photo, Remove
Back Cover

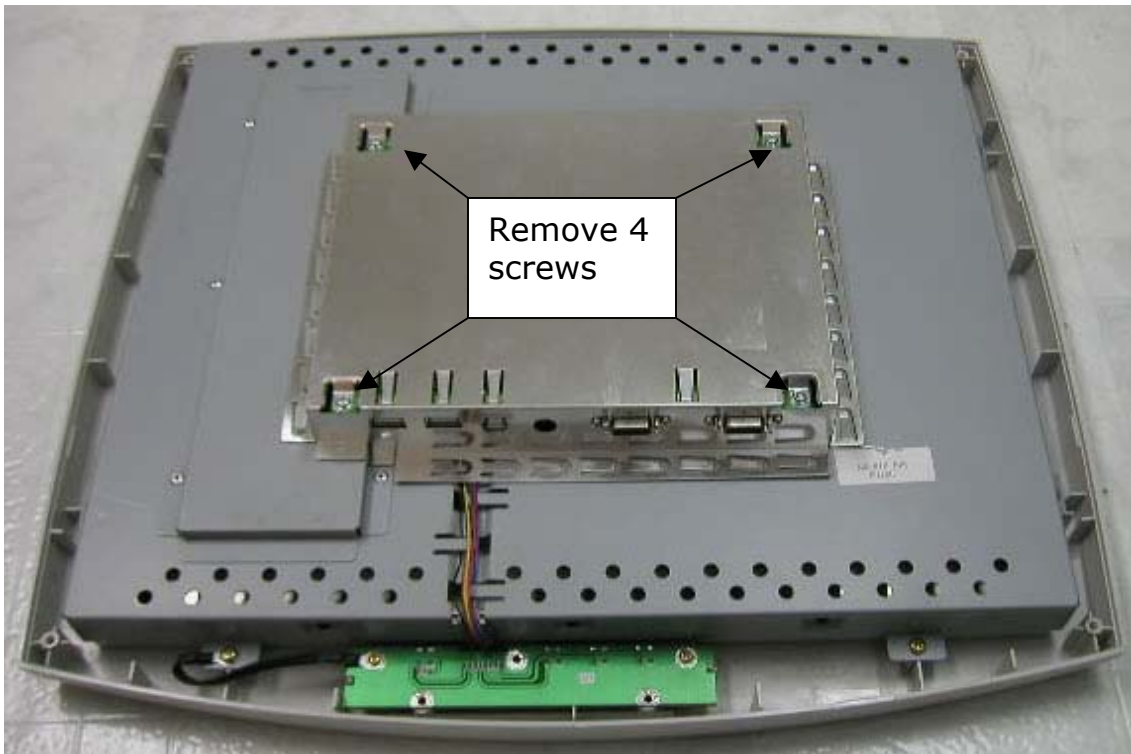
Remove 4
screws

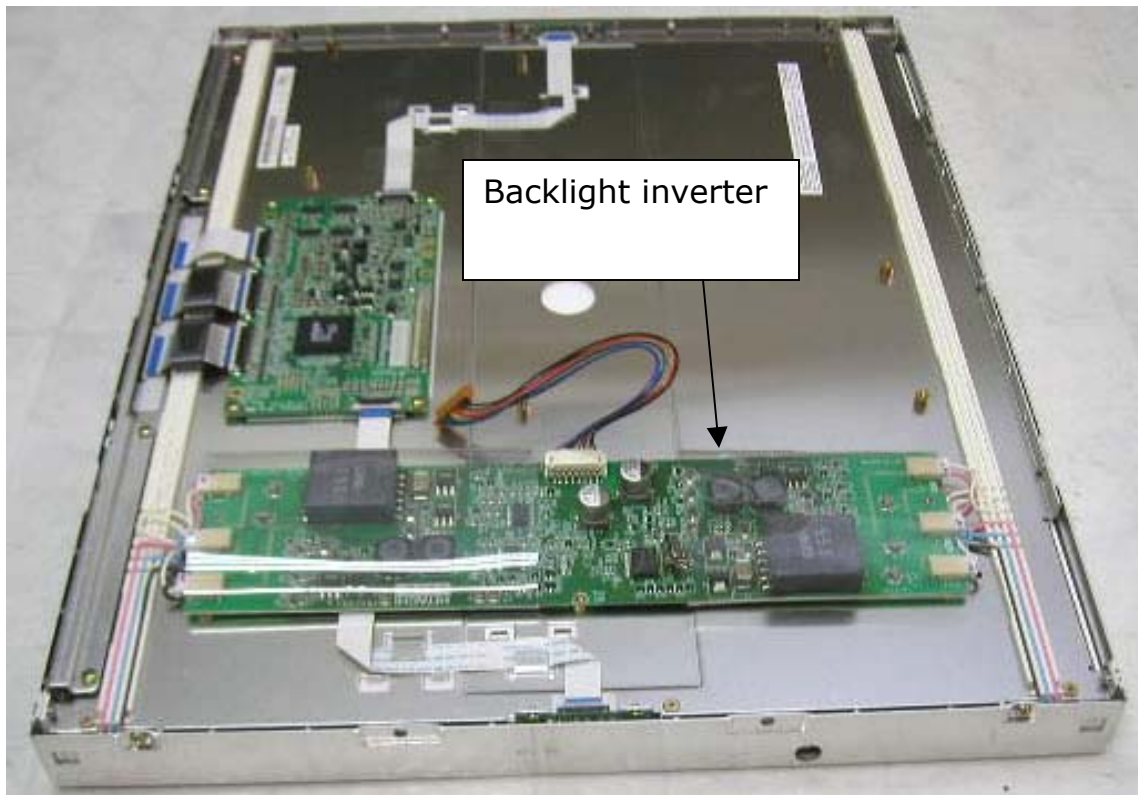
Disconnected 6 backlight connectors and Control connector. Replace with MoniServ INVC551MSS. Re-install all component, metal chassis, circuit board and cover back. VP181 should back to work again.
