**MoniServ, Inc**

## Backlight Inverter Installation Procedures for Dell 1701FP

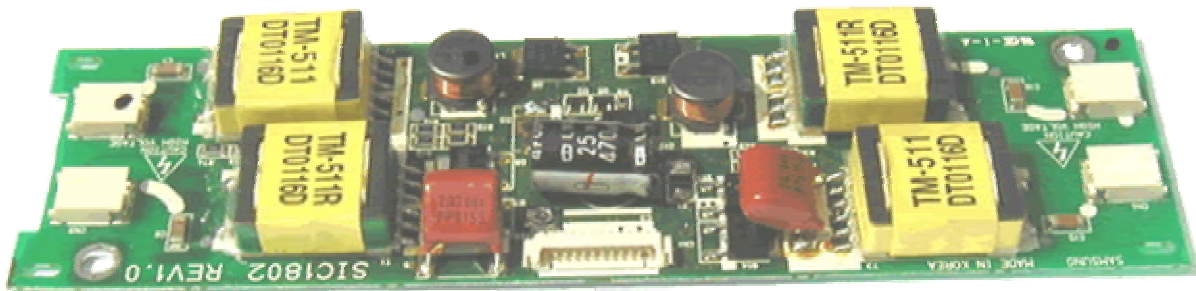
Original Backlight Inverter board showed Photo.

Disconnected 4 backlight connectors. Replace with MoniServ SIC1802MSS. Re-install all component, metal chassis, circuit board and back cover. Dell 1701FP should work now.
