Remove and installation Procedure for Gateway FPD1830

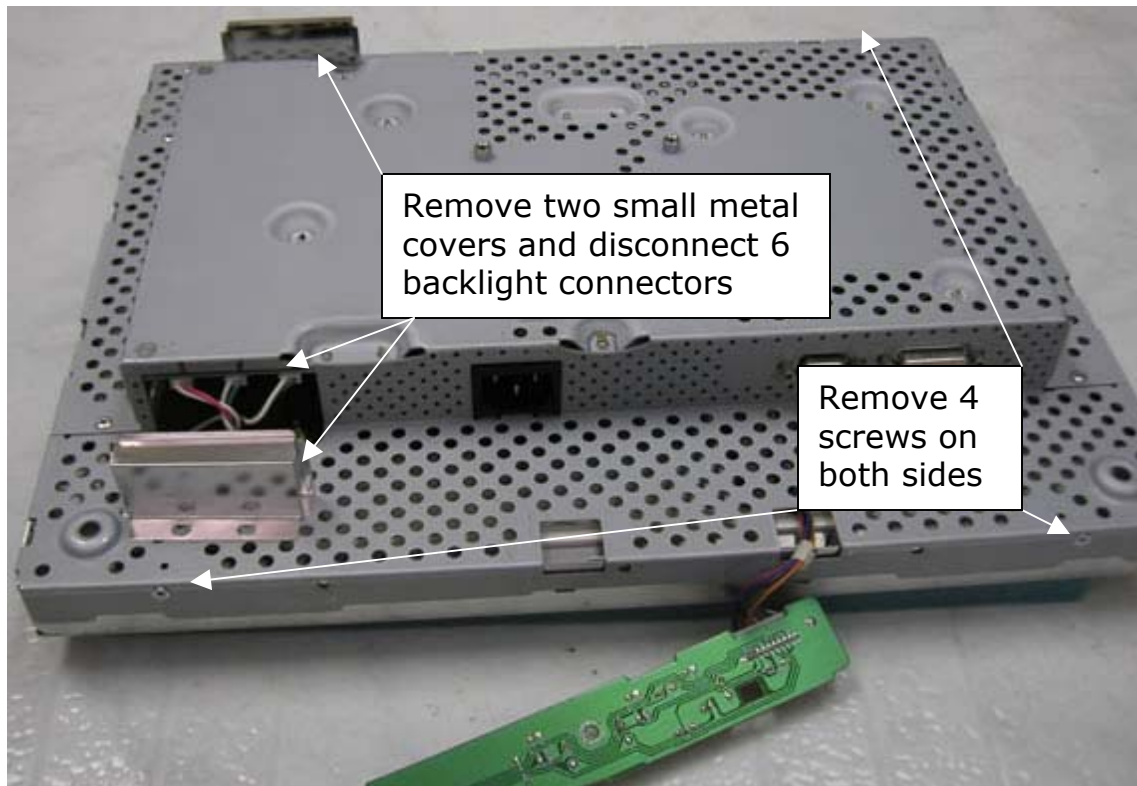
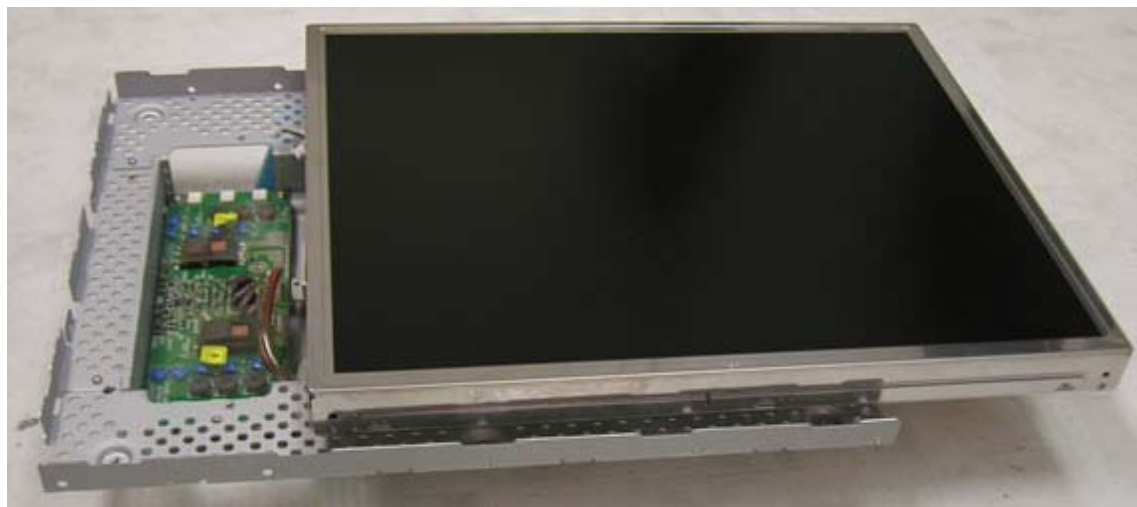
Carefully flip over the panel assembly (Because there are no screws between TFT Panel and Metal Chassis) and lift TFT Panel up about 1/2 inch and slowly shift TFT Panel to right side, Now you can clear see the inverter (Photo shown above)
